Red de Observacion del Nivel del Mar para America Central (RONMAC)

El Salvador Reconnaissance Report (Acajutla)

Wednesday, June 21, 2000

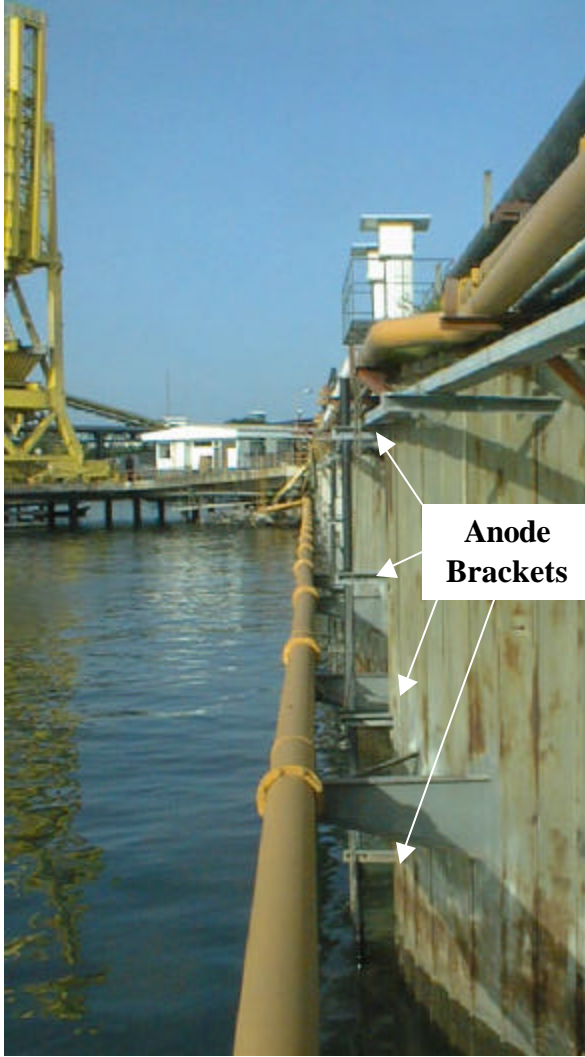
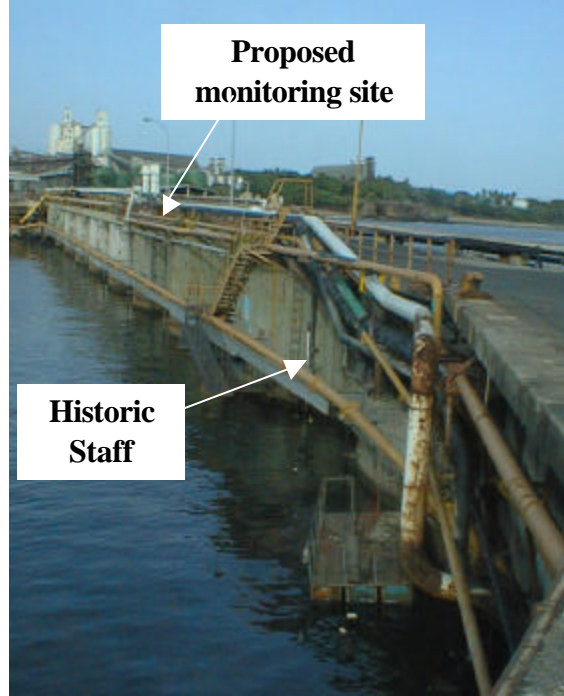
The most desirable of the three sites that were looked at was located on the shoreward end of the pier, near the historic site warehouse. This site is less exposed to the ravages of the sea and it is in a area that is not subject to vessel traffic. This site has existing brackets that are presently utilized for anode wires (see photo and drawing).

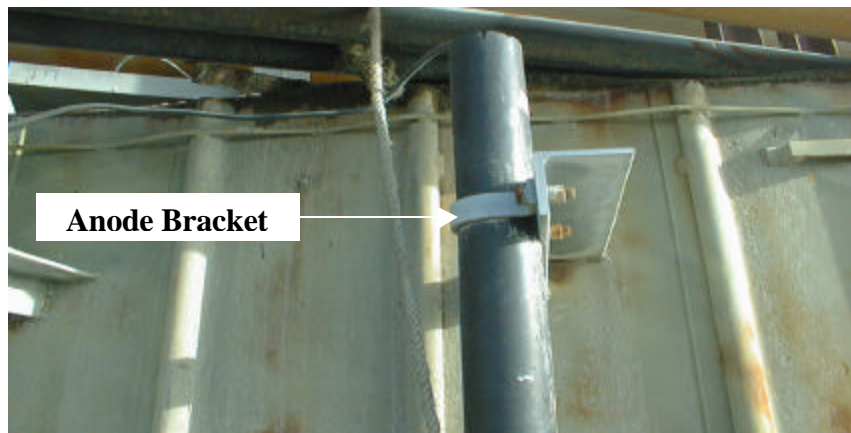
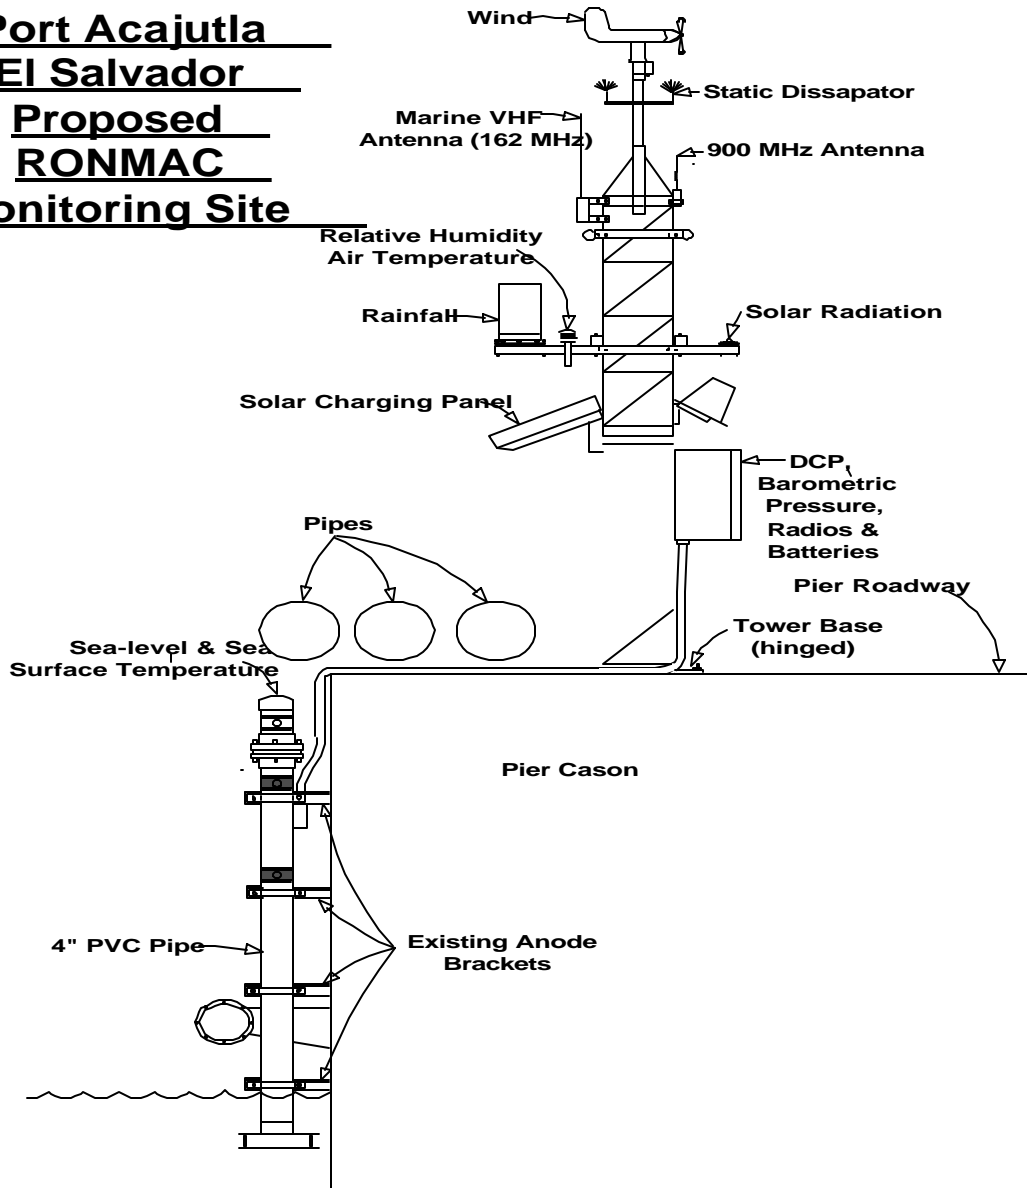
Port Acajutla
El Salvador
Proposed
RONMAC
Monitoring Site

The Proposed RONMAC Monitoring site is located on the extreme edge of the pier roadway, as near to the pier “pipes” as possible. Since the pier is very high above the water, the monitoring site tower is only two sections high and will not require guy wires.
