Good and Poor Building Practices in the HRHIP

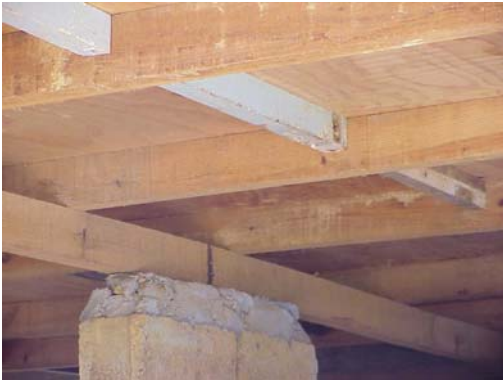
Intermediate support provided where spans are too great. This will help reduce deflection of floor joists and subsequently add rigidity to the flooring system. Runners are tied with ½ inch mild steel rods. This anchors the structure to the foundation. Solid bridging is used to support to the edge of the plywood floor covering. Lateral movement can be further resisted by embedding into the concrete ¼”x3”x9” steel plates on either side of the joist, which are then screwed into the joist. See picture below.

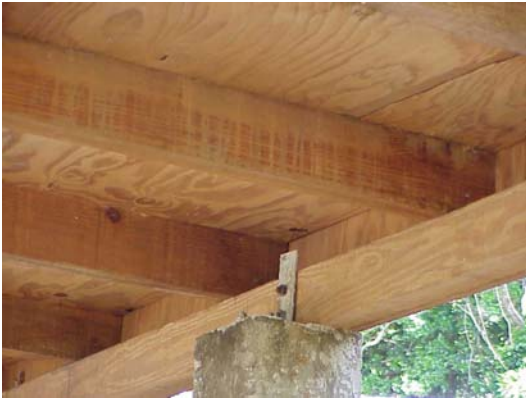
The runner is secured to the foundation by a steel plate fastened with nut and bolt. This method securely anchors this element to the foundation.

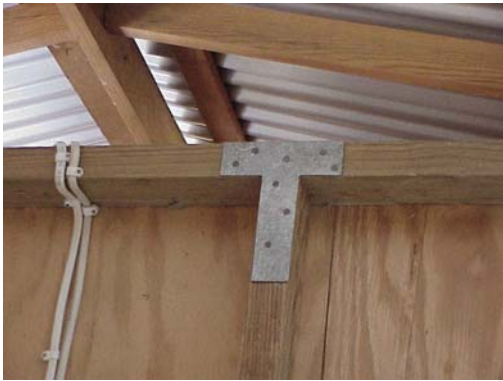
‘T’ strap used to connect the stud to top plate.

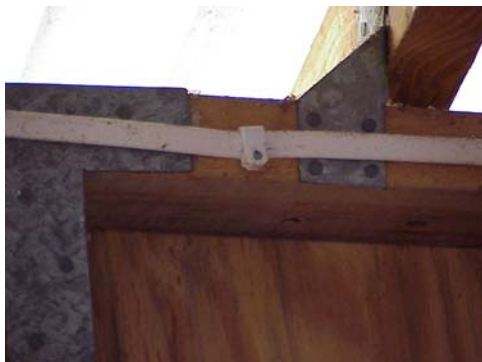
Hurricane clamps connects rafter to top plate. This assist in resisting uplift during high winds. ‘T’ straps used to connect studs to top plate.

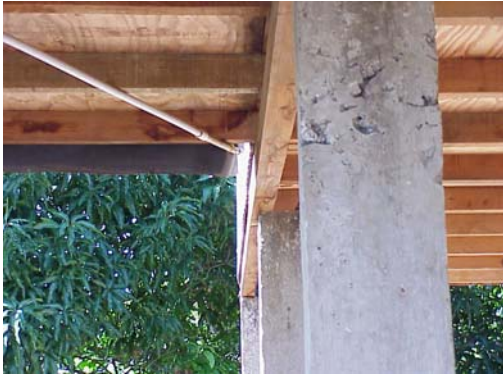
Load bearing elements should be placed over the centre of supports (not to the edge). Loading should not be off centre as shown, as only a limited section of the concrete column is being relied upon to carry the load. This practice could lead to failure of that section of the column where load is applied.

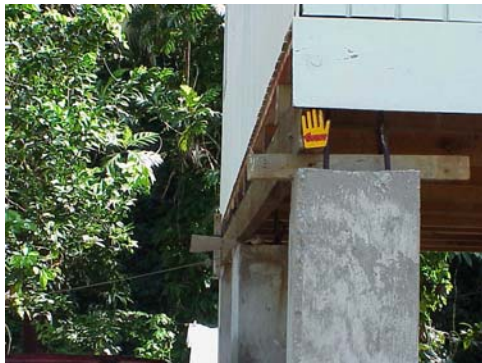
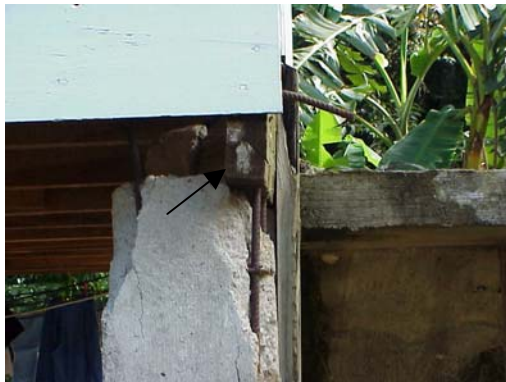
Breaking and cracking of the support column results when tensile column reinforcement is used to secure bearers to foundation. Instead, one of the following measures should be used to provide adequate fixing to receive bearers: 1) use mild steel rebars (mild steel is more pliable) or 2) cast mild steel 'U' clamps or steel plates into concrete column.

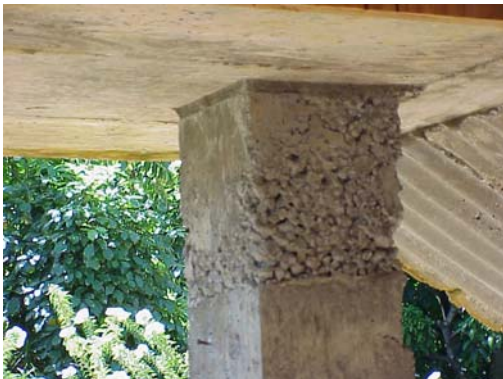
This picture shows an example of a poor concrete mix. Honey-combing is the result of 1) ungraded coarse aggregates, 2) insufficient fine aggregates, 3) the use of too much water in the mix and 4) possibly poorly constructed formwork, which allows the sand/cement paste to escape.

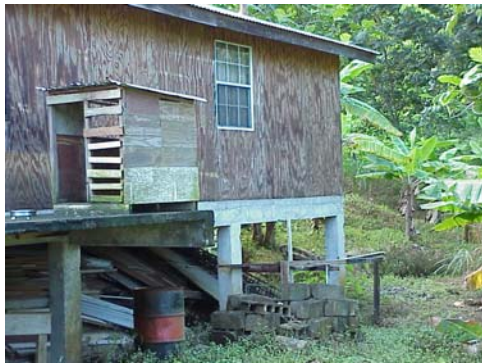
This structure is of composite timber and masonry construction. The lack of knowledge of reinforced concrete construction and the absence of professional input has jeopardized the structural integrity of the finished construction shown. The next picture shows deflection of the floor.

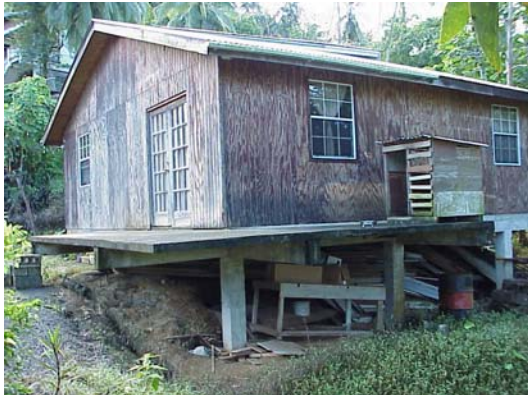
Concrete floor slab showing sign of deflection. The absence of guttering is causing serious damage to the exterior cladding. Guttering should be provided at eaves to limit the continuous saturation of the plywood cladding, which results in unsightly discoloration and eventual degradation of the material.

A gable roof is used here instead of a hip roof in an area where the degree of exposure to strong winds is high. Also the glass windows and doors are not protected against high winds. Hurricane shutters should have been installed. They are no longer fashionable but they are important.

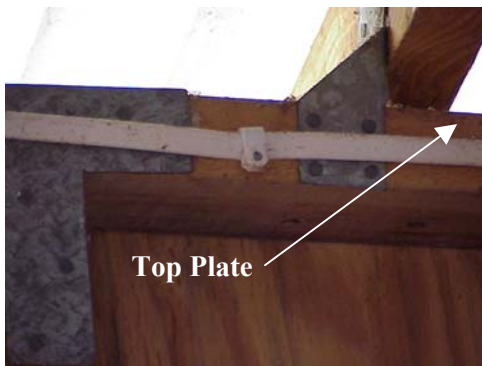
This picture shows good practices but there are areas to be given attention here. Example the top plate should be doubled because it carries the weight of the entire roof. The gap left open at junction with the top plate and the underside of the roof covering is vulnerable during high winds; it should be closed to avoid winds from entering the structure. Finally, no seat cut is provided on the rafter at its intersection with the top plate.

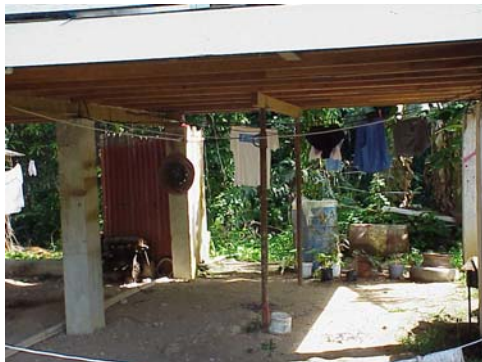
Joists that cross large spans will deflect if they do not have the require depth to span the opening without intermediate supports. The floor will spring as a result.

In this picture it can be seen that intermediate support had to be installed as a corrective measure. A simple formula can be applied to determine the depth of the joist require to span an opening unsupported: depth of joist = $1/25$ of span + 2" [or + 50mm if calculated in metric]

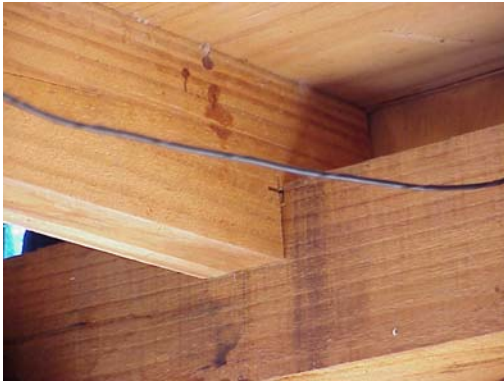
Joist should not be notched at intersection with bearers (or sill plate) as shown. This practice reduces the property of the section in shear (which is greater at the supports) and reduces the effective depth of the section with regards to deflection. In general this practice reduces the load-bearing capacity of the member.

Notching of rafters is to be avoided at all costs.

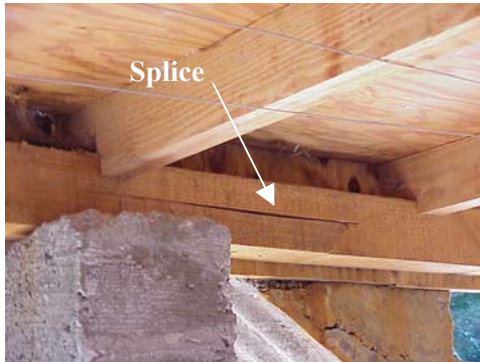
Splices in floor joists and bearers must occur directly over a support. Failure to apply this practice will increase deflection in the respective member, resulting in a bouncing floor and possibly eventual failure if dead and live loads are increased on the floor. All joints especially in floors must occur directly over a support. If not they are likely to fail.
