APPENDIX II

O A S STRUCTURAL VULNERABILITY ASSESSMENT
ST KITTS ISLAND

APPENDIX IV
Recommended Retrofit Action

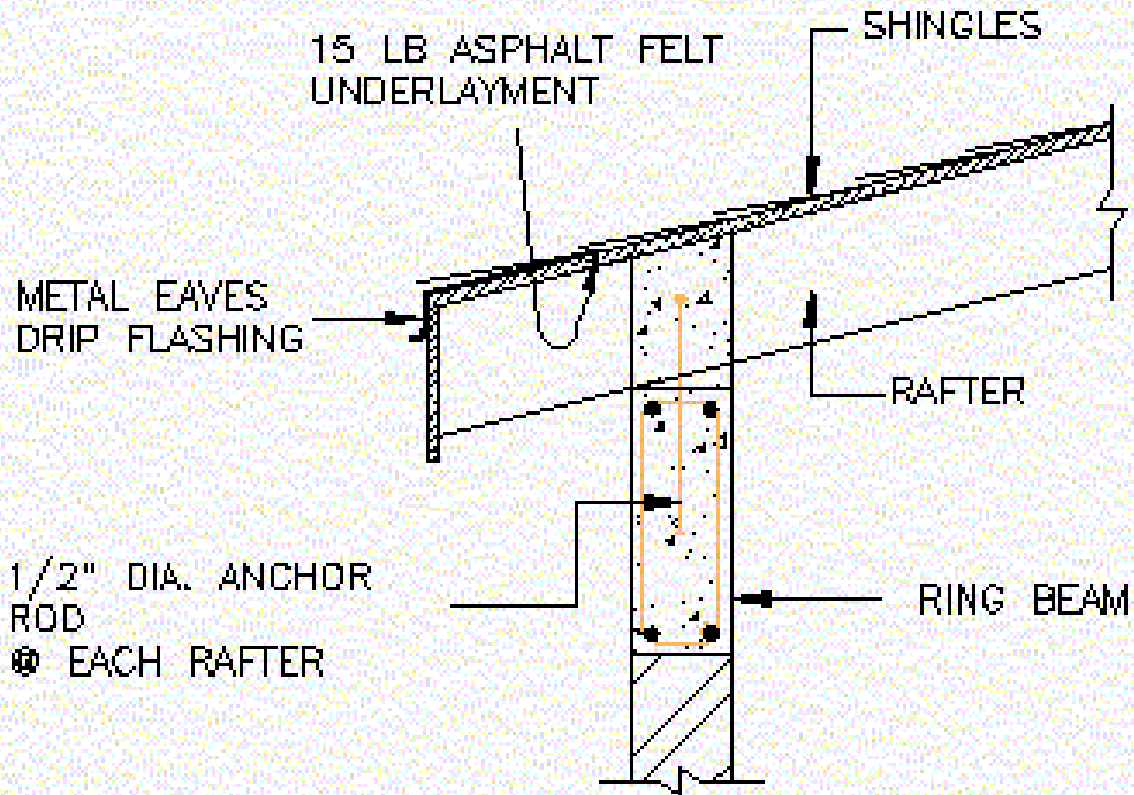
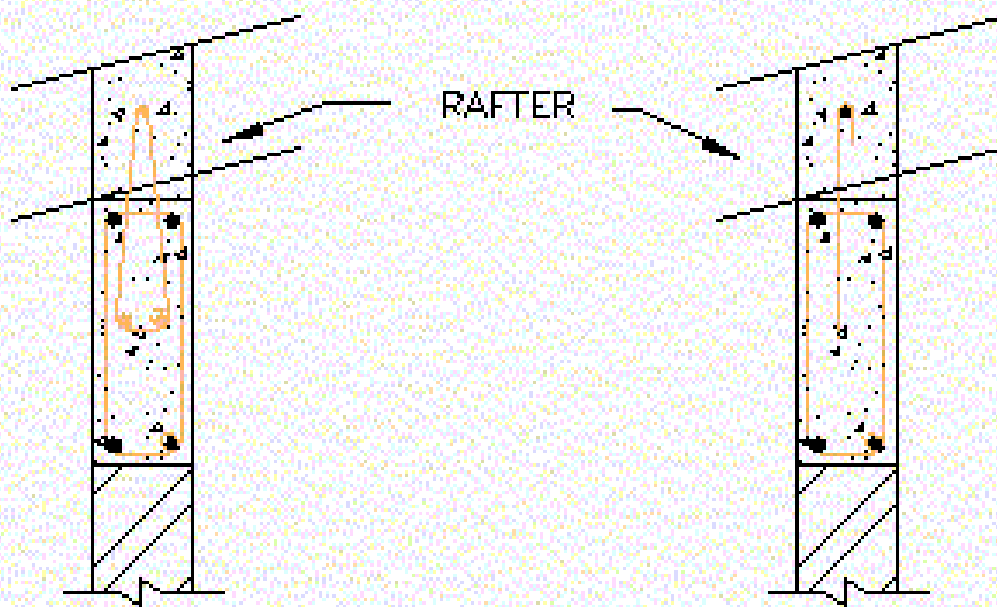
APPENDIX 1

WOOD RAFTER ANCHORING PRACTICE
NO LONGER RECOMMENDED DUE TO BAD EXPERIENCE
(WITH RAFTER SPLITTING UNDER HURRICANE WINDS)

There is a verandah on one side of the building. The main roof extends over the verandah. The windows are not protected by shutters. The rafters are anchored to the wall with a detail which is no longer recommended. See Appendix I.

The timber rafters are held down on the concrete ring beam by a steel rod which is threaded through the rafter and anchored in the ring beam. This method of anchoring the rafter is no longer recommended. See Appendix I.
