Red de Observacion del Nivel del Mar para America Central (RONMAC)

El Salvador Reconnaissance Report (Acajutla)

Wednesday, June 21, 2000

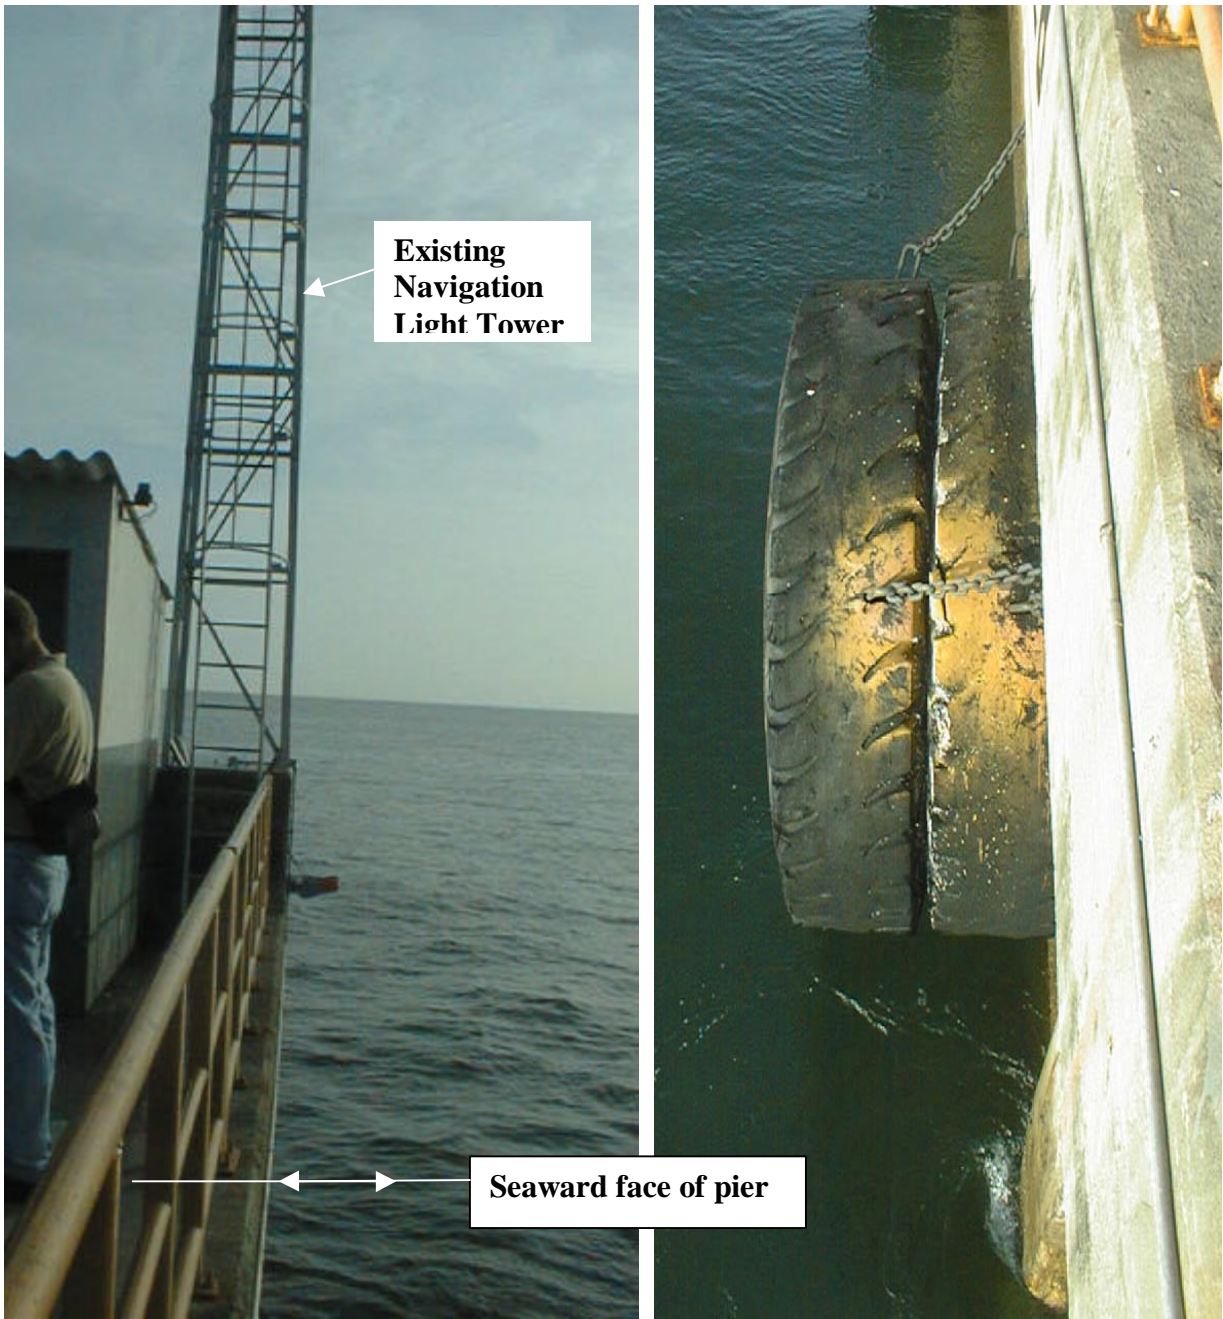
The end of the pier offers a marginal location. It is very exposed to the open ocean and to shipping mishaps. This location can be used but is the least desirable of the sites that were investigated.

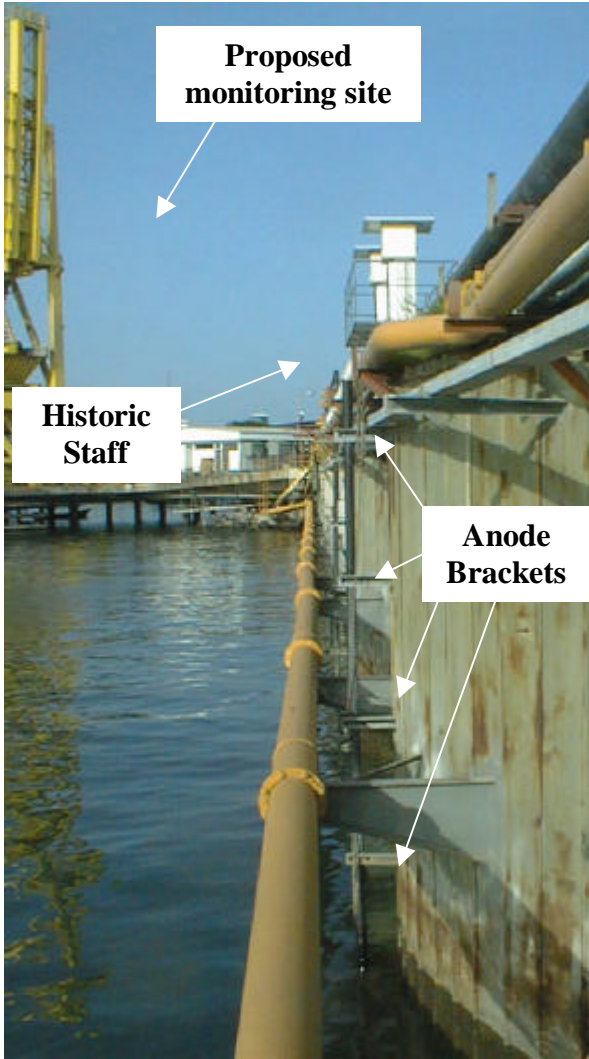
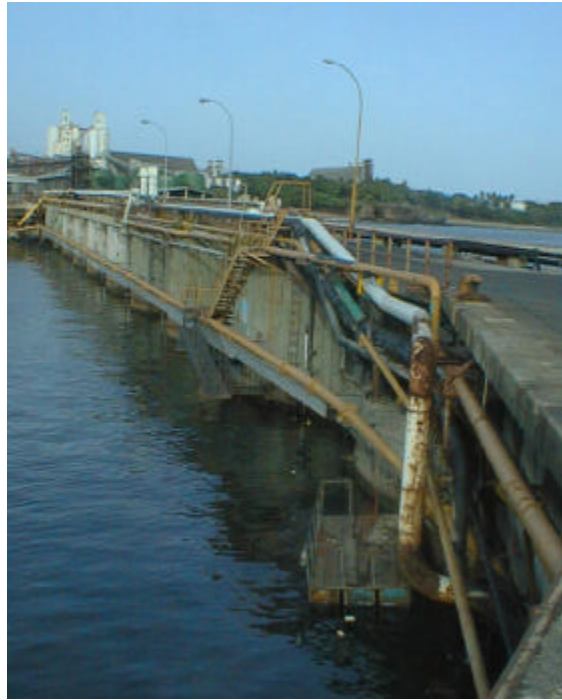
The most desirable of the three sites that were looked at was located on the shoreward end of the pier, near the historic site warehouse. This site is less exposed to the ravages of the sea and it is in a area that is not subject to vessel traffic. This site has existing brackets that are presently utilized for anode wires (see photo and drawing).

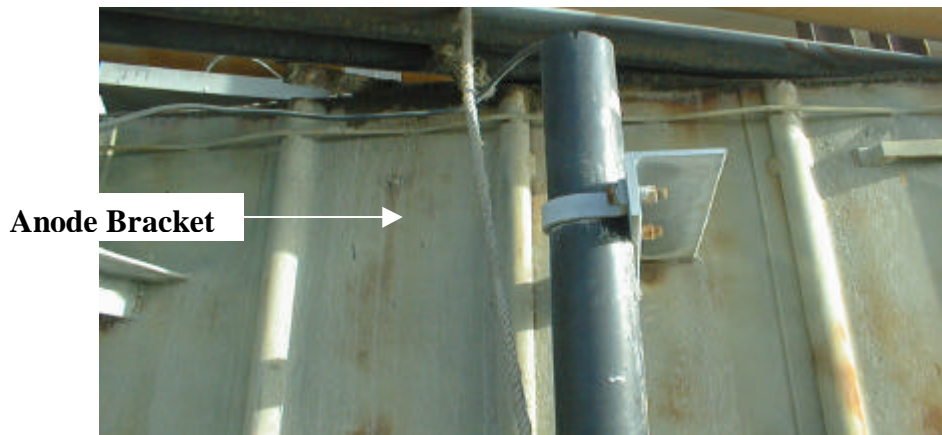
Port Acajutla
El Salvador
Proposed
RONMAC
Monitoring Site

The Proposed RONMAC Monitoring site is located on the extreme edge of the pier roadway, as near to the pier “pipes” as possible. Since the pier is very high above the water, the monitoring site tower is only two sections high and will not require guy wires.
