Red de Observacion del Nivel del Mar para America Central (RONMAC)

El Salvador Reconnaissance Report (Acajutla)

Wednesday, June 21, 2000

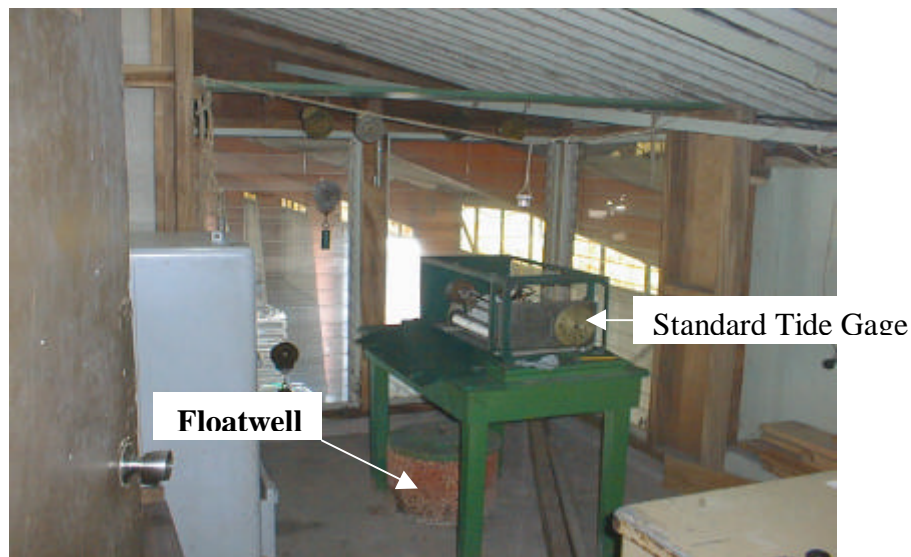
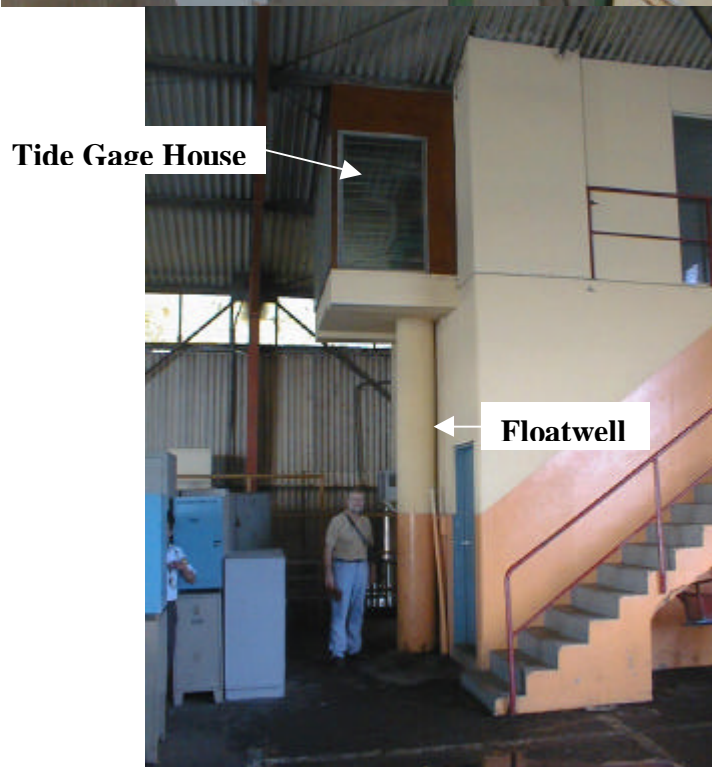
We toured the Port facility. We looked at the existing tide measurement site.

After discussing the suitability of using the historic site for the RONMAC monitoring installation, it was decided that such a plan would require that the historic site be modified extensively. It was decided to look at alternative sites.

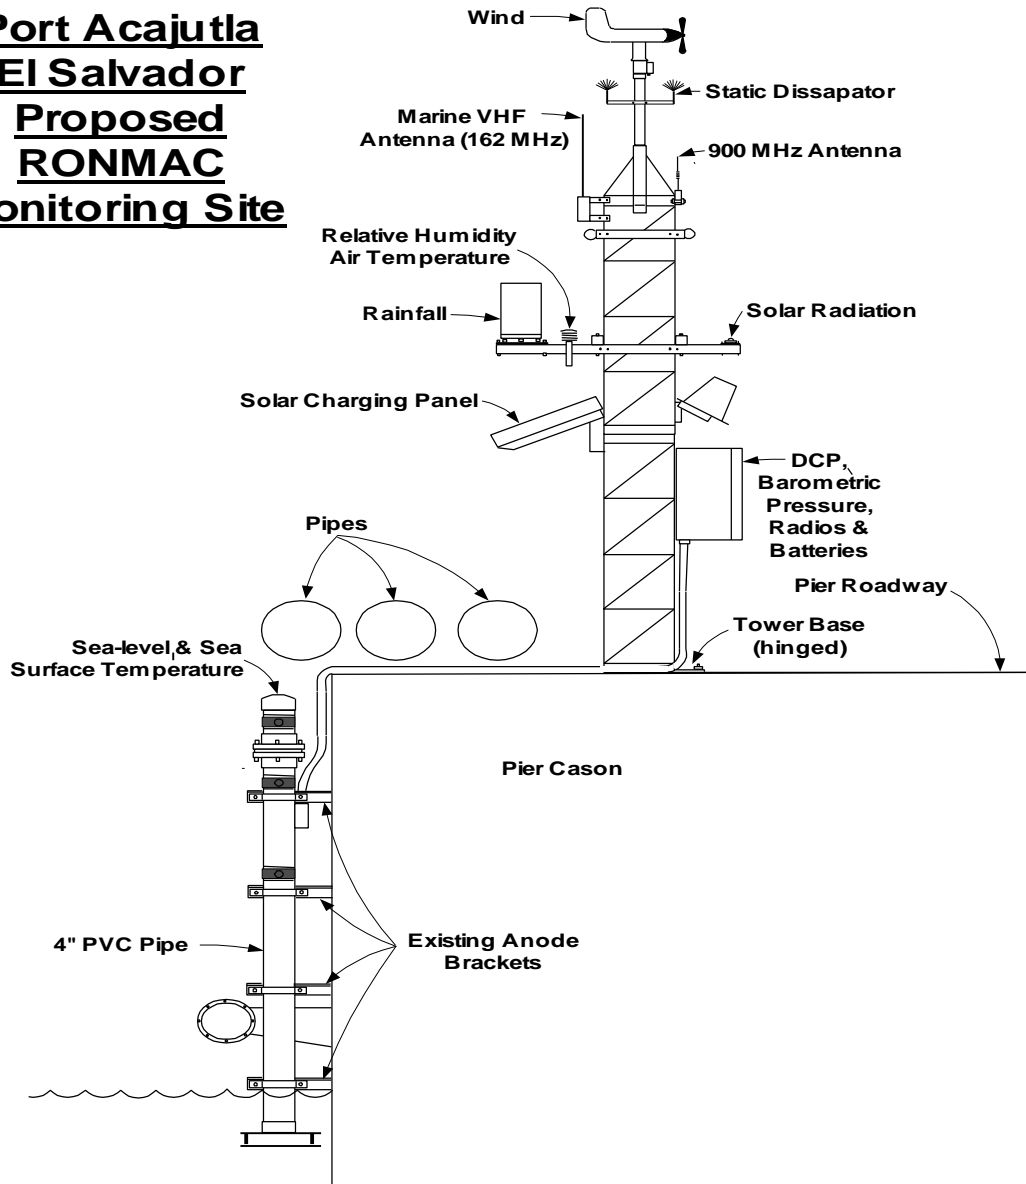
Port Acajutla
El Salvador
Proposed
RONMAC
Monitoring Site

The Proposed RONMAC Monitoring site is located on the extreme edge of the pier roadway, as near to the pier “pipes” as possible. Since the pier is very high above the water, the monitoring site tower is only two sections high and will not require guy wires.
