Structural Vulnerability Assessment for St. Kitts and Nevis

Post-Georges Disaster Mitigation Project in Antigua & Barbuda and St. Kitts & Nevis

July 2001

This report was prepared under contract with the OAS by Elmes and Associates, Engineers, Surveyors, Architects. Basseterre, St. Kitts

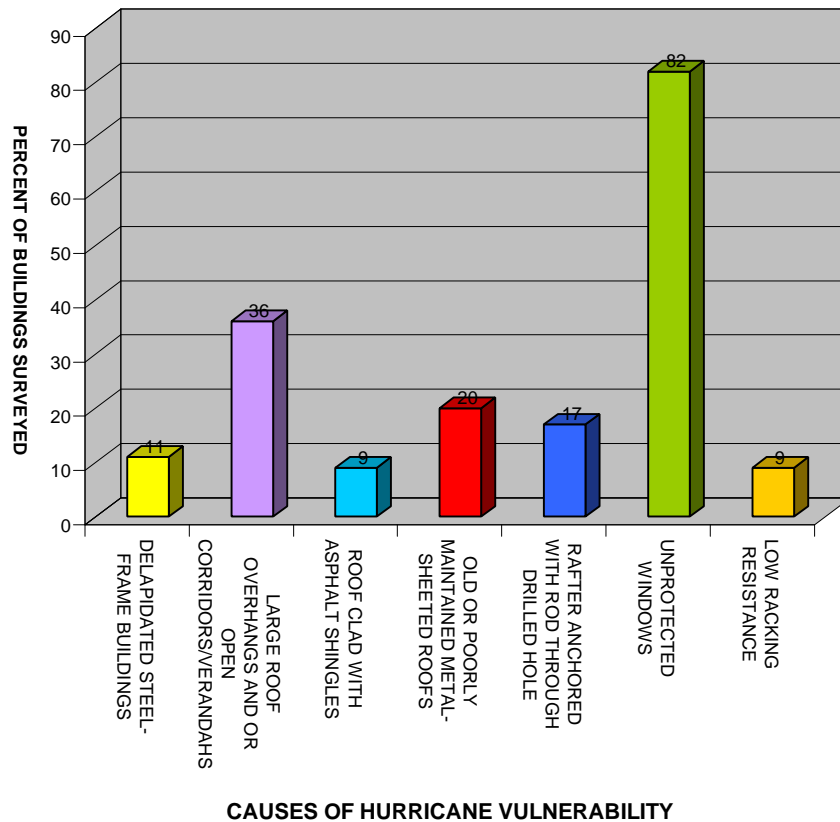
The Bar Chart below shows the distribution of wind vulnerabilities among the buildings surveyed.

The deficiency most often observed was lack of protection for windows and equipment access openings in walls. 81 percent of buildings surveyed fell into this category.

The most severe deficiency encountered was the poor state of repair of the class of building called “pre-engineered steel-framed structure”. The deficiency was particularly severe where this type of structure also had walls of “cement fibreboard” as opposed to concrete block. The percentage of buildings falling into this category was small (21 percent).

Other notable points of vulnerability were open, roofed corridors where the main roof continues across the exterior wall to form the roof of the corridor (18 percent of the buildings) roof clad with ordinary asphalt shingles which are not rated for installation in high wind areas and buildings with rafters anchored by means of a steel rod passed through a hole drilled in the rafter - a detail which is no longer recommended (10 percent of the buildings).

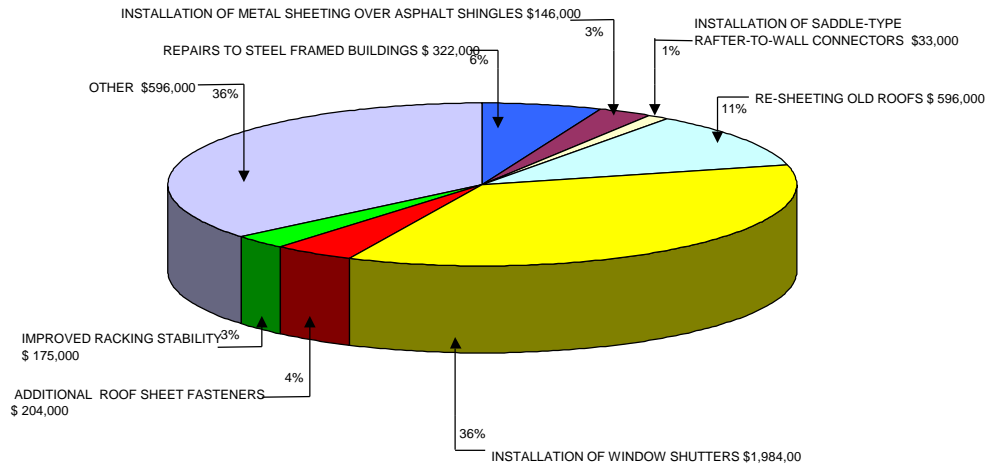
RETROFITTING COST BY CATEGORY
AS A PERCENT OF TOTAL COST (EC \$)

The distribution of this amount among the different categories of retrofit action is shown graphically below.

The total estimated cost of the recommended retrofitting work is EC \$5,400,000.
