RONMAC Monitoring Station Report

Report Date: August 13th, 2001

Station Name: *Rio Lempa, El Salvador*

Purpose of Present Visit: *Installation*

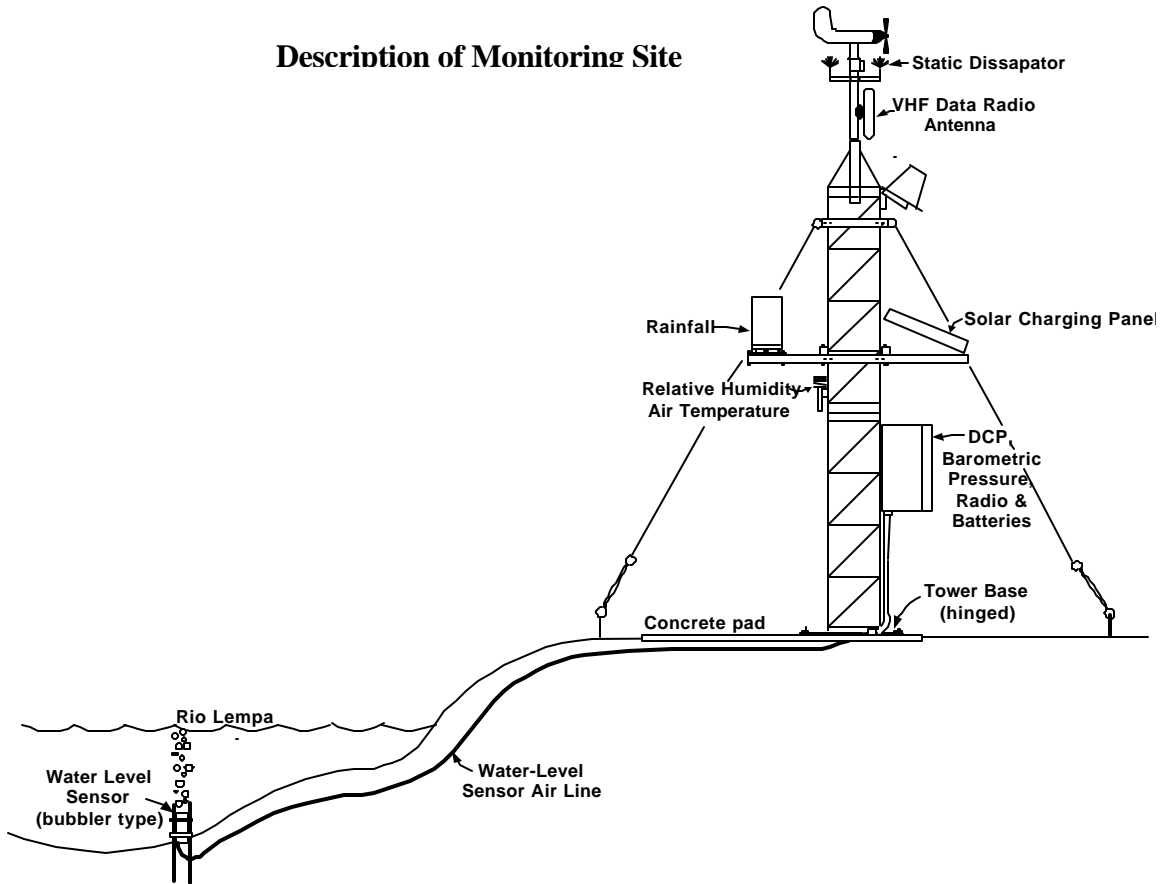
Description of Monitoring Site

Description of Location: The tide station is located on the north shore of the Rio Lempa at La Pita near the entrance of the river to the Pacific Ocean. The monitoring site is located on the property of "Rancho Lempa Mar" on the river side of the property west of the main building on a concrete pad.

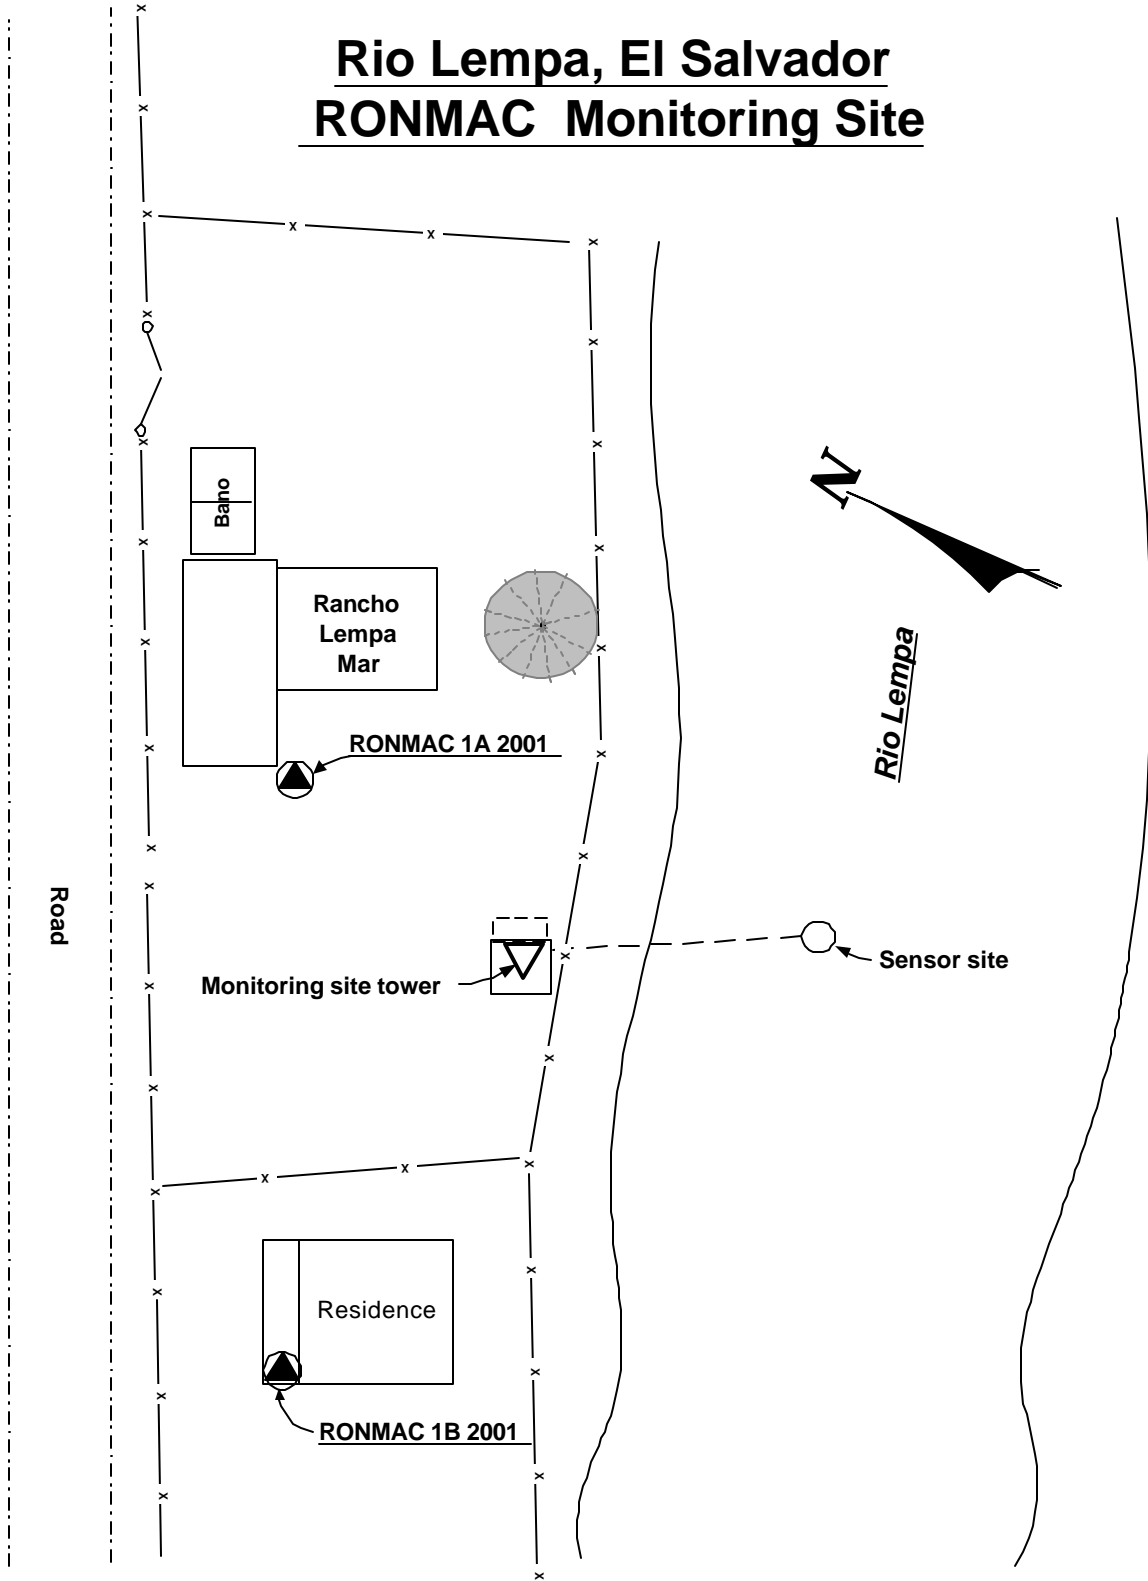
Rio Lempa, El Salvador RONMAC Monitoring Site

TO REACH the monitoring site proceed south from San Nicolas Lempa at the intersection of Highway CA-2 and the Rio Lempa Road 20.5 km to La Pita. The station is on the property of the "Rancho Lempa Mar" near the southwest corner of the fenced property, next to the fence along the river.

"RONMAC 1A 2001" is a brass disk set flush in the concrete foundation extension at the south west corner of the main building, 0.4 ft (0.12m) southwest of the concrete block corner of the building, 31 ft (9.5m) south of the centerline of the road, 41 ft (12.5m) north of the fence along the river bank.

"RONMAC 1B 2001" is a brass disk set flush in the northeast corner of the front porch of the residence of Tanyo Argueta on the north side of the "Rancho Lempa Mar", 2.9 ft. (0.88m) west of the centerline of the doorway into the house, 39 ft. (11.9m) south of the centerline of the main road, 34 ft. (10.4m) north of a fence-line along the river bank
